INSPECTION OF DAM AND RESERVOIR IN CERTIFIED STATUS

Name of dam Oroville Dam Dam No. 1-48 County Butte
Type of dam Earthfill Type of Spillway Gated Concrete Weir and Chute
Water is feet 47 feet above spillway crest and 61.4 feet below dam crest.
W.S. 860.6

Reason for inspection Special spillway inspection

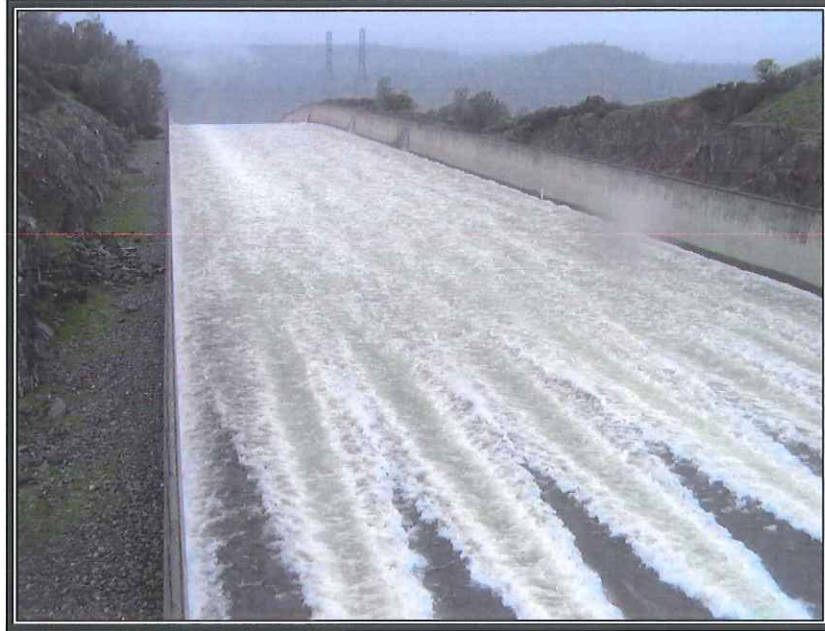
1. The flow in the chute was normal, with no observed signs of distress. Note the wall drains flowing in the background.

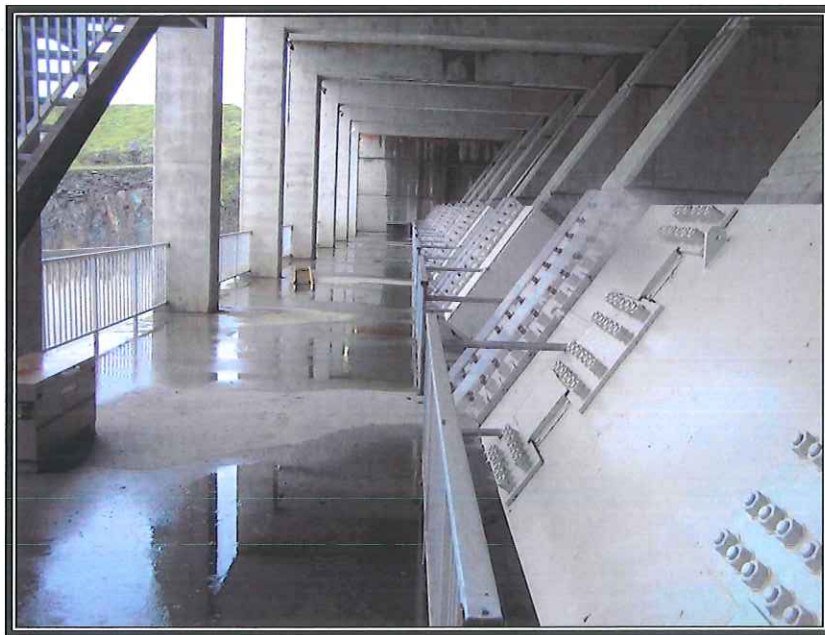
2. The trunnion beams and anchors are shown. The water on the inspection deck was from drifting rain. Conditions appeared to be normal.

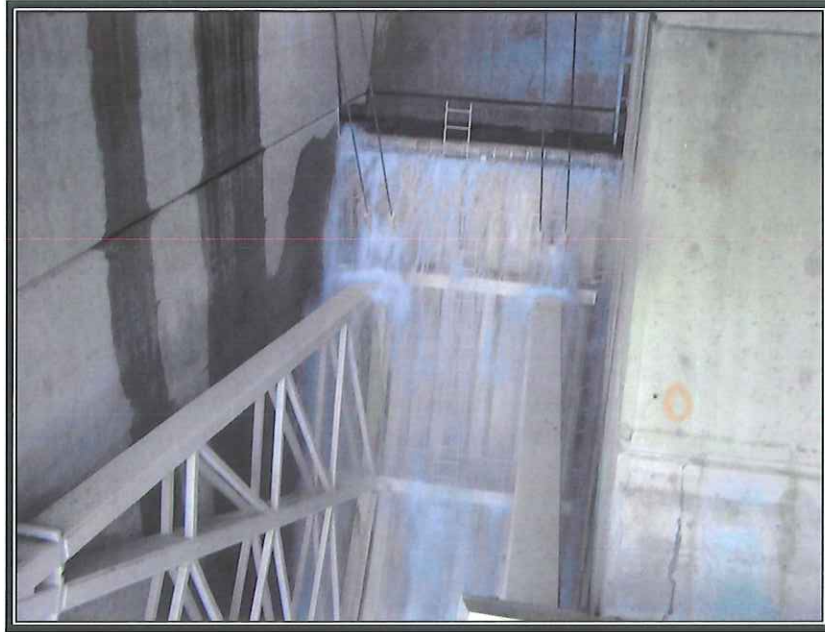
3. Typical seal leakage conditions are shown. Note the good condition of the protective coatings.

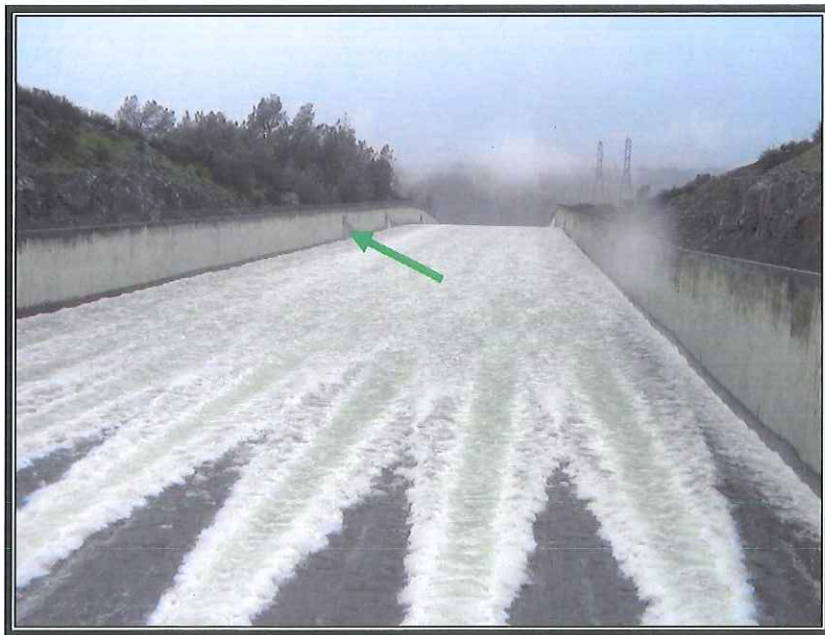
4. The drain flow from both chute walls started at the location indicated by the arrow. The drains from this point to the flip bucket appeared to be flowing.

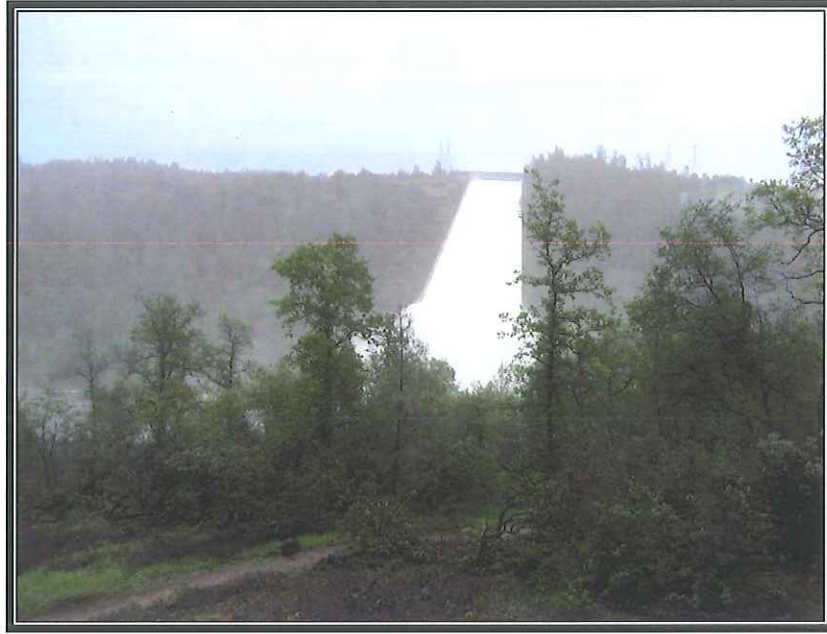
5. The overall conditions in the chute and flip bucket are shown. The flow across the flip bucket appeared to be normal and symmetrical.
